Vacuum Vessel disludging works

Objective: To find permanent solution for slow discharge rate issue

ASH MANN VACUUM SERVICES

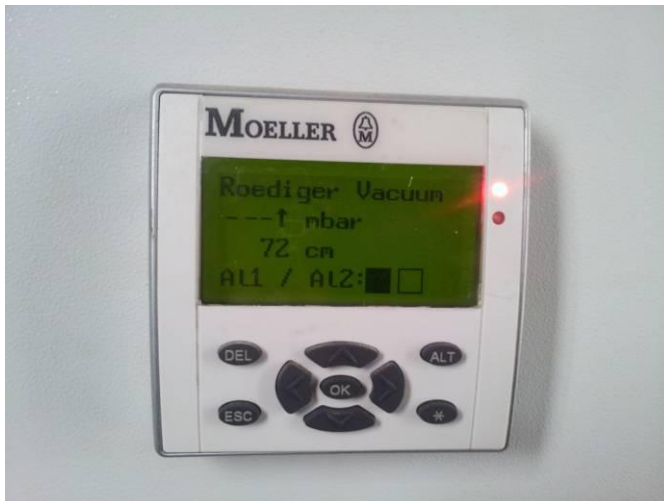
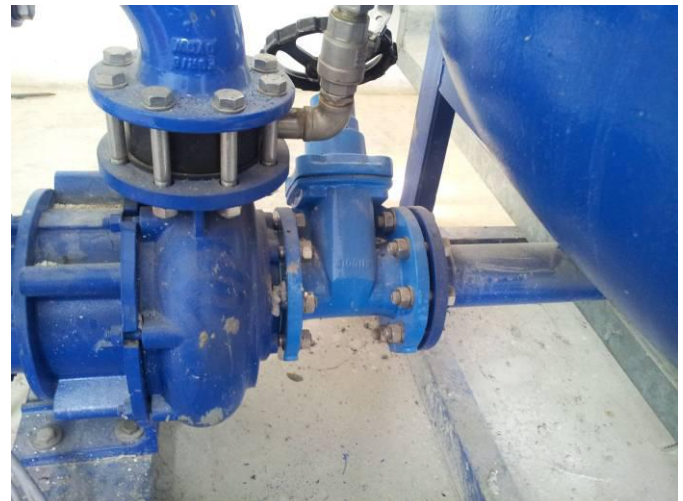
Water level has reached the max level and auto cut off the vacuum pumps

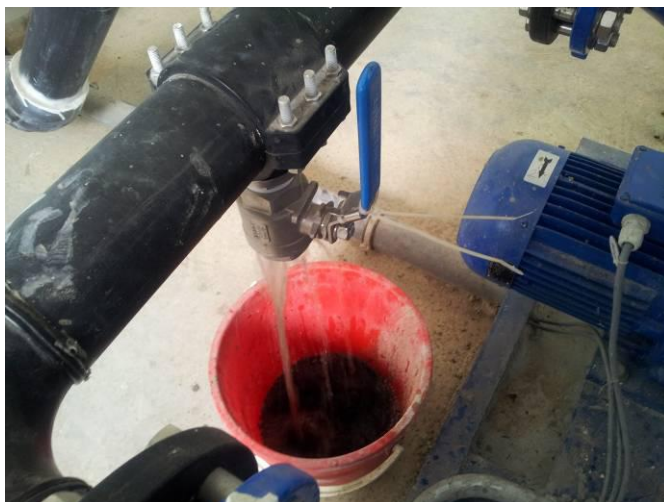
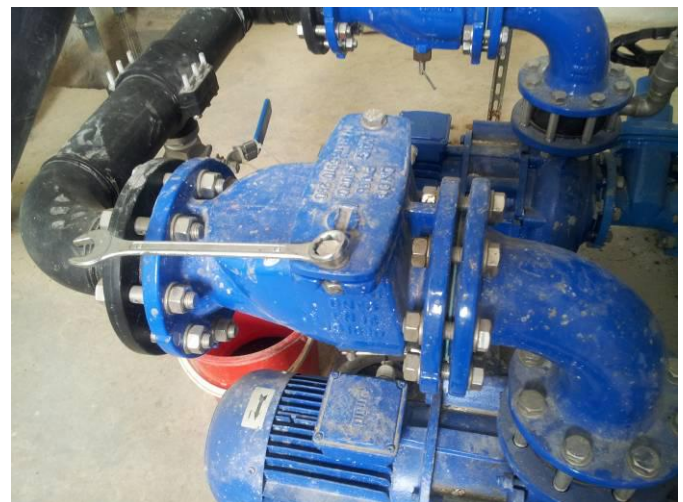
Some remaining water was flushed out manually to avoid excessively spillage in the vacuum station

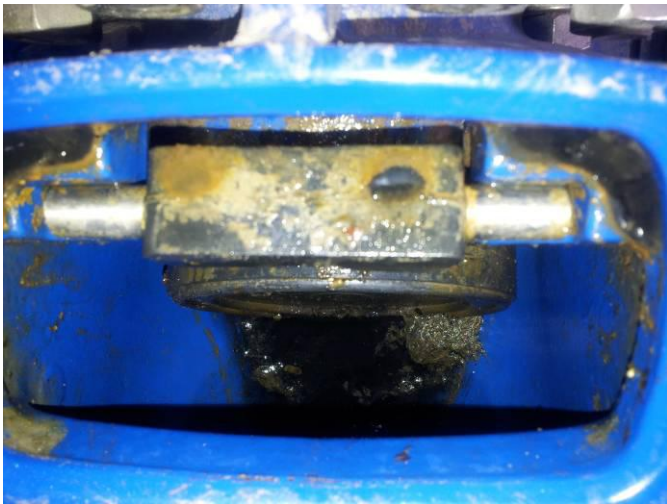
No sand detected

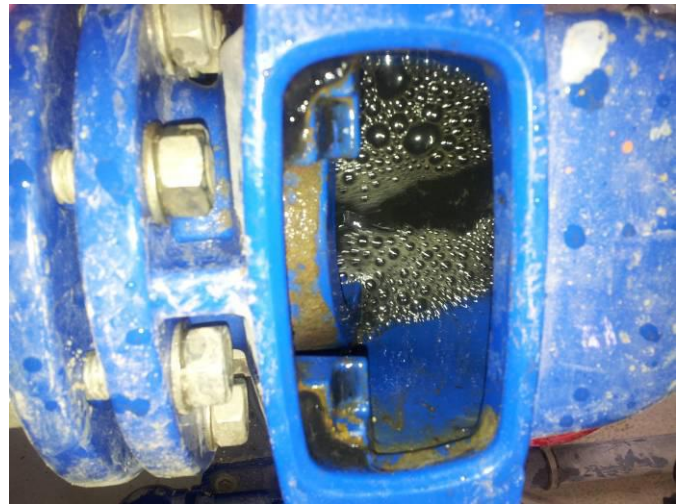
discharge pump is turned on, no water flowing

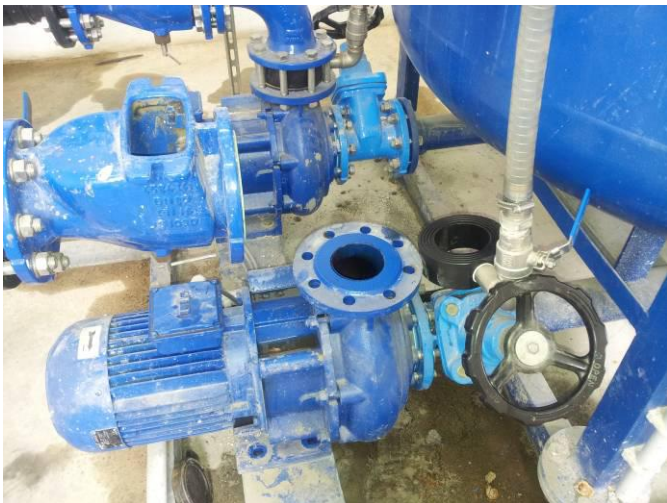
One way valve is opened, it's clean and no water was flowing although discharge pump was turn on.

It's proven that the discharge pump was not able to receive/pull water from vacuum vessel and it starts to vibrate terribly after a few seconds' of running it.

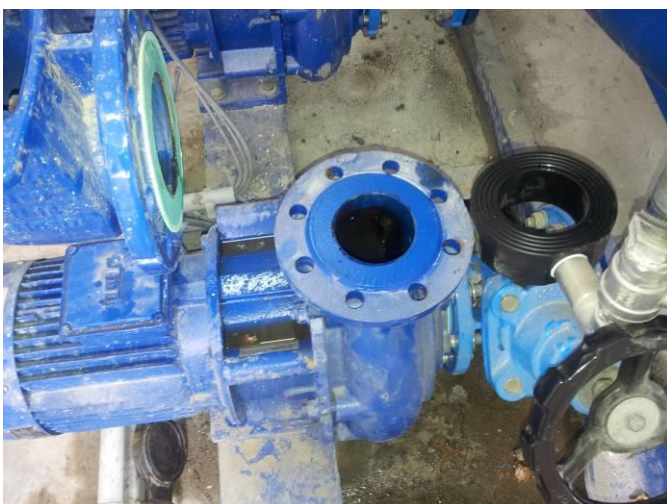
Discharge pump looks clean and no sand detected

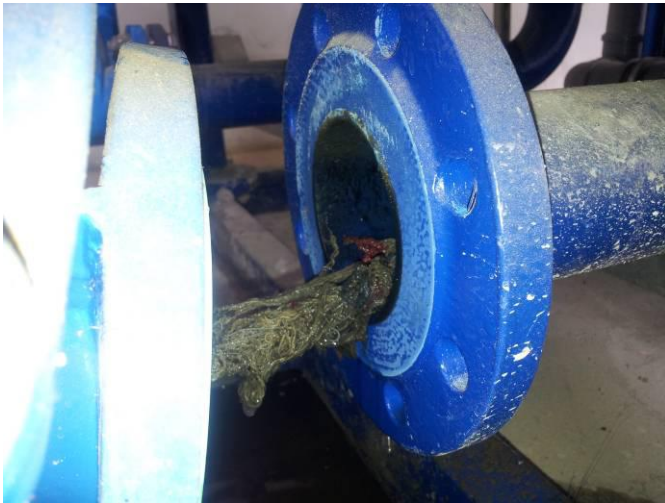
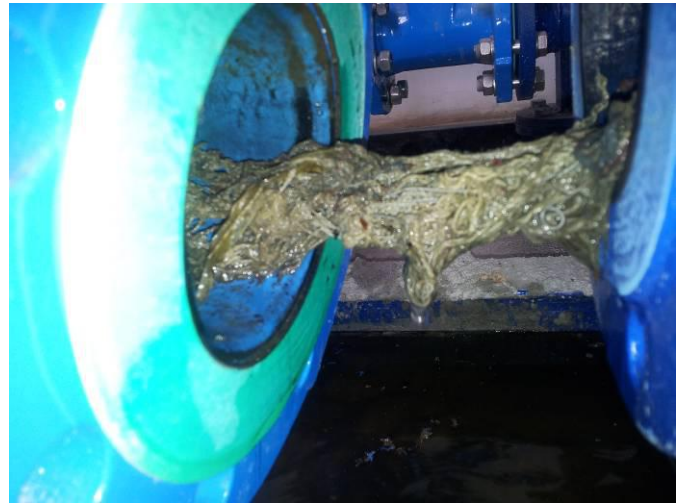
Cause of Problem: Batches of strings and clothes stuck at the 90deg elbow under the vacuum vessel and got compacted that eventually restricted the discharge flow to as high as 95%..

A few batches of strings n cloths found in the discharge line

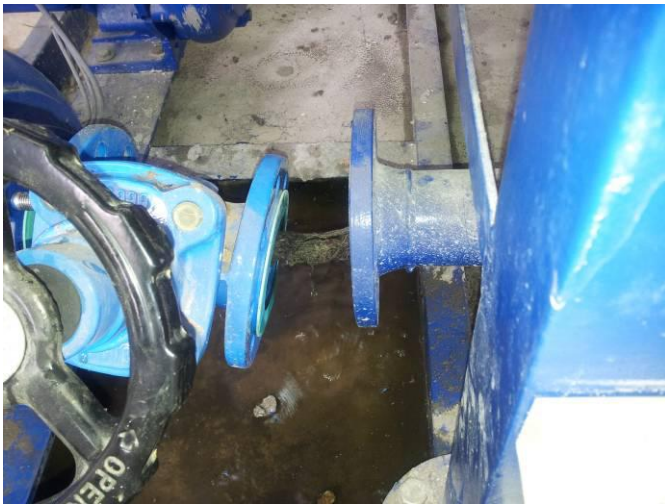
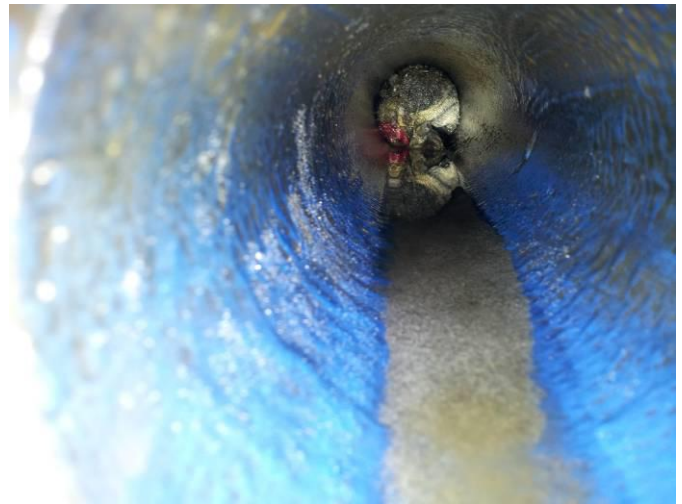
Compacted batches of strings n cloths

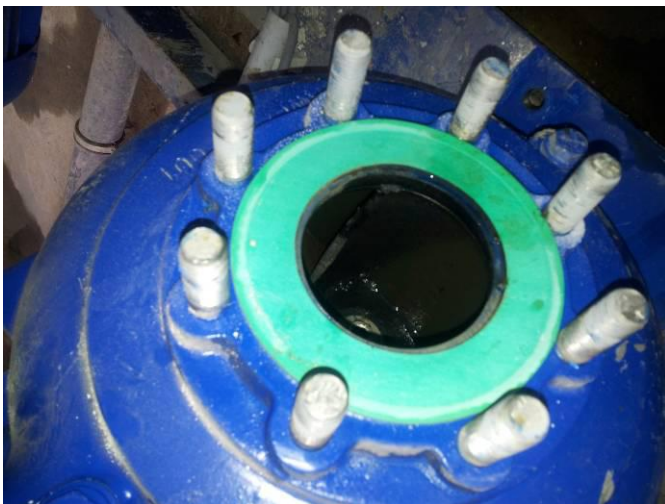
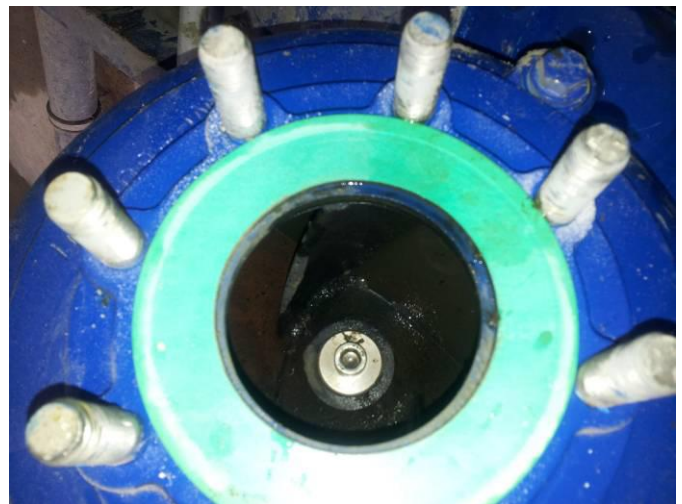
Discharge pump does not show any sign of damages or stuck

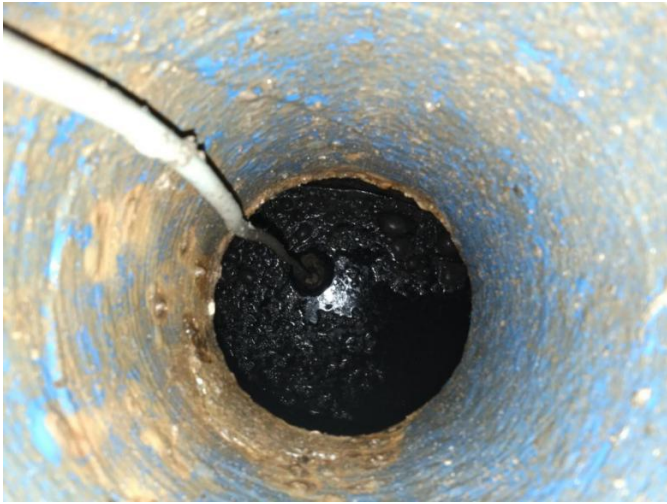
View from sensor manhole

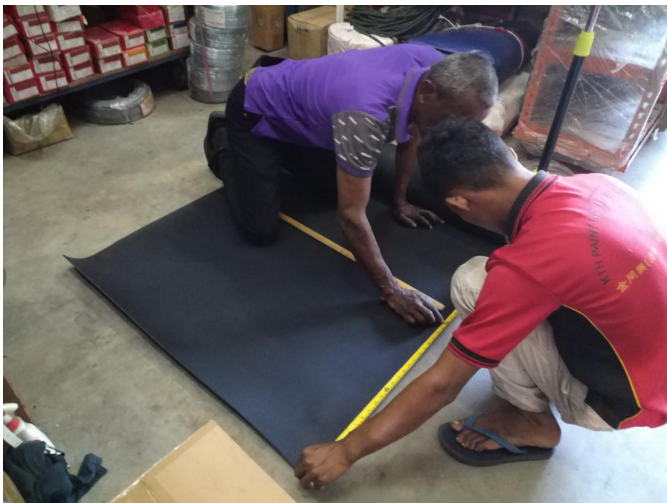
Custom made rubber gasket

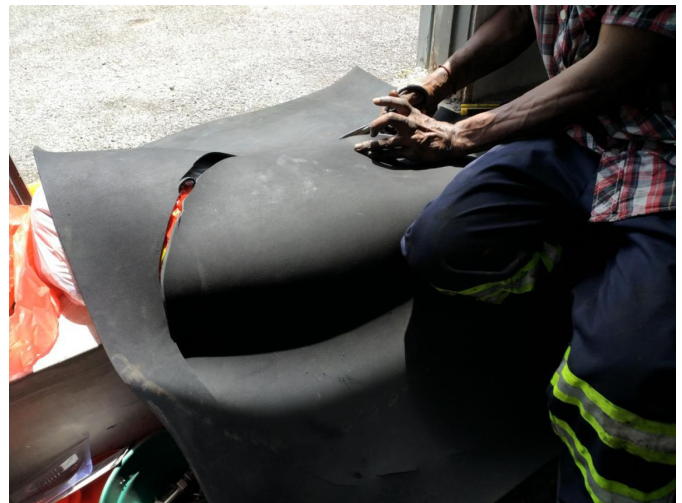
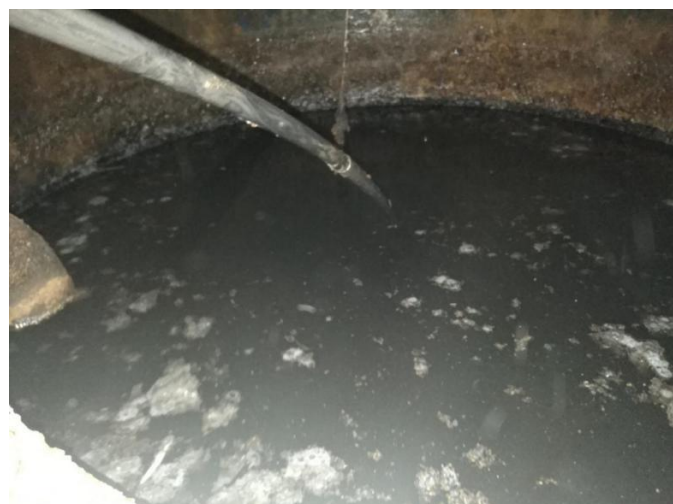
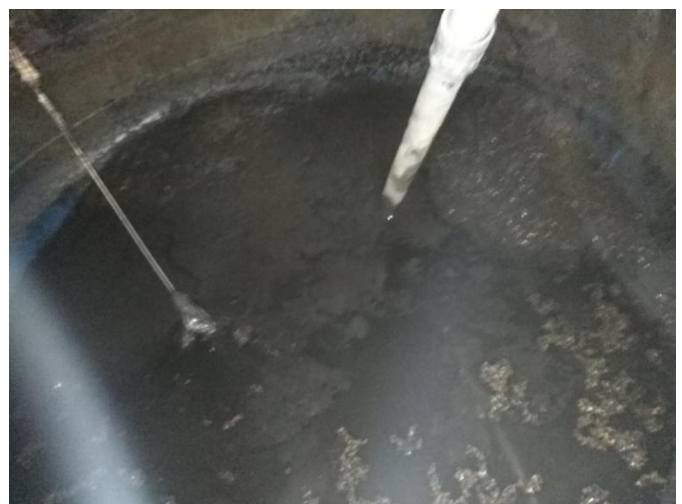
Sewage water manually removed and removed 1 feet height of sand collected at bottom portion of the vessel

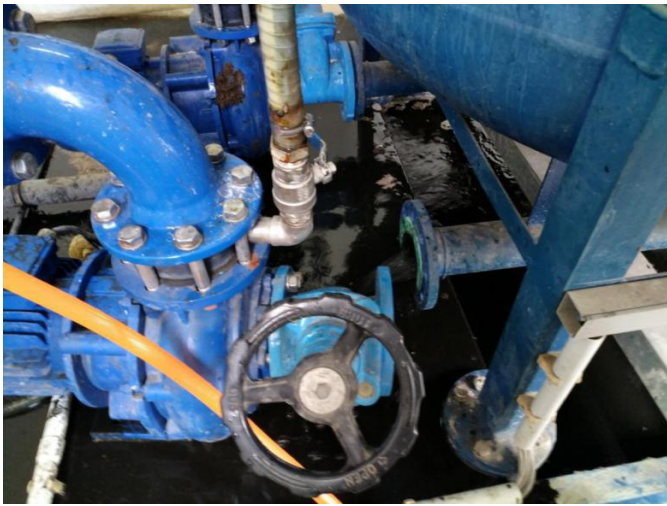
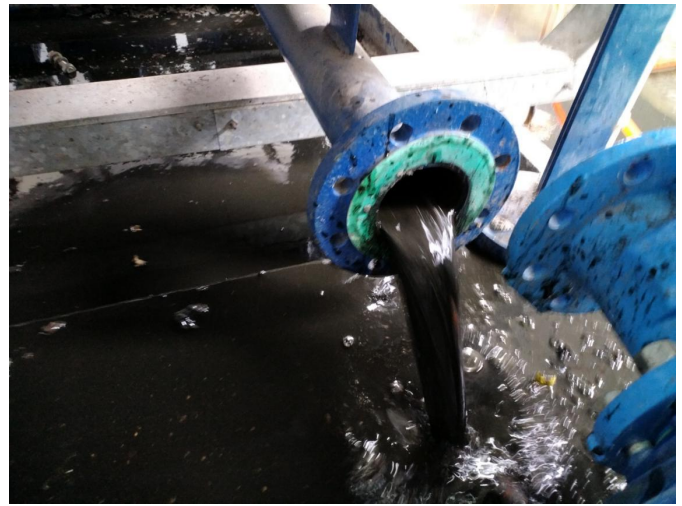
Removing it has enable the flow of the discharge

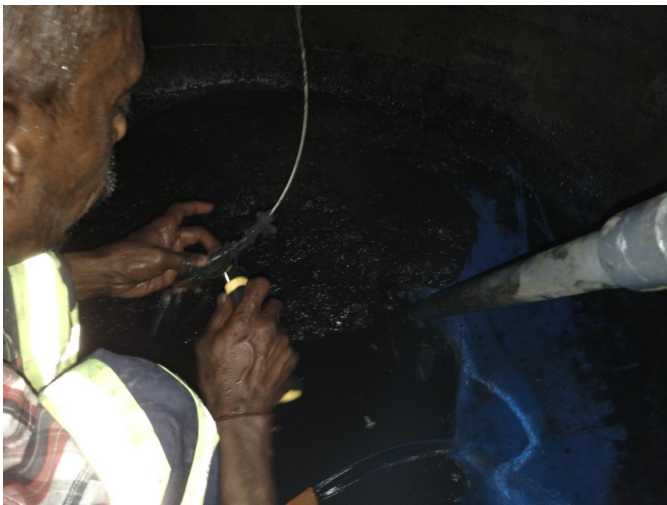
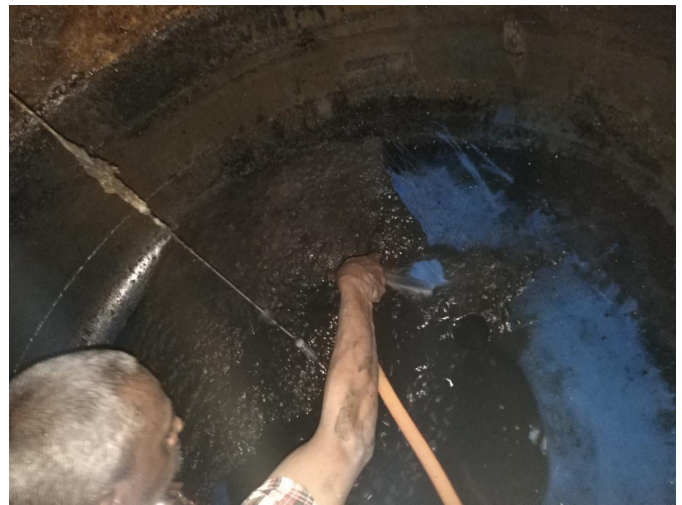
Sensor was tied up with a bundle of strings , carefully removed

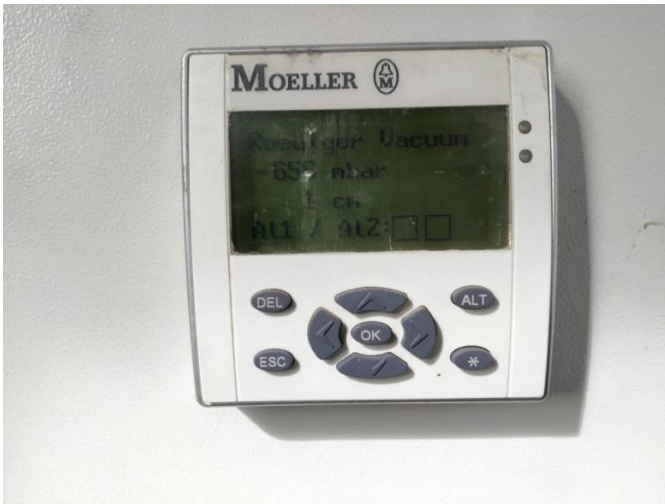
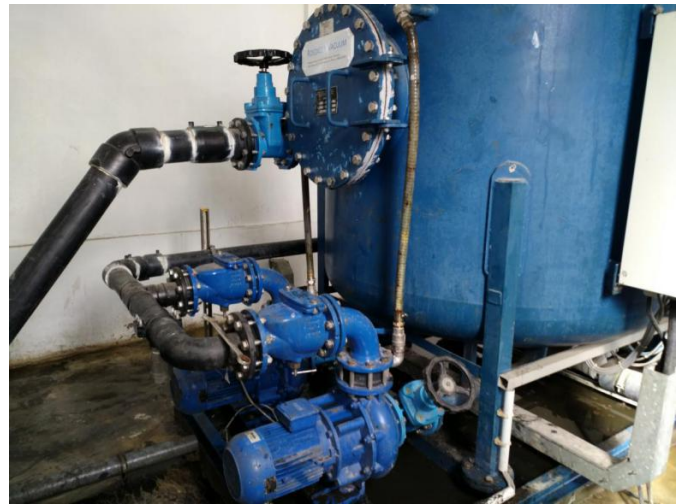
Internal Leak test conducted for an hour , no pressure leak detected
