Vacuum pump condition inspection :

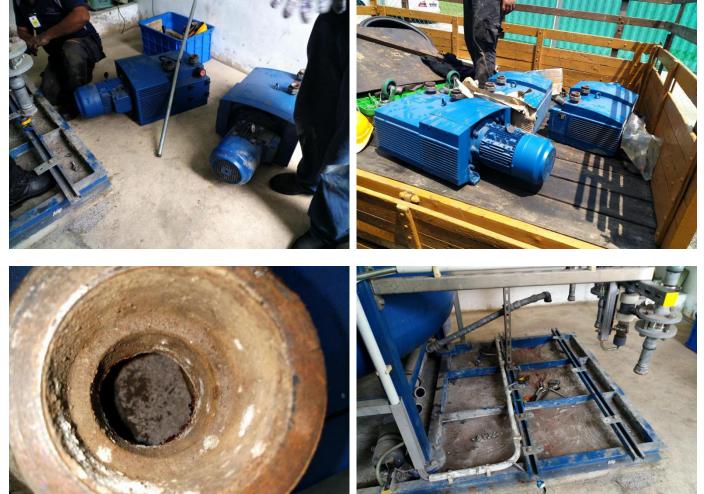
- Vanes found has been warn out
- cylinder has severe scratch marks
- Excessive wear at filtration and exhaust area
- Bearings damaged

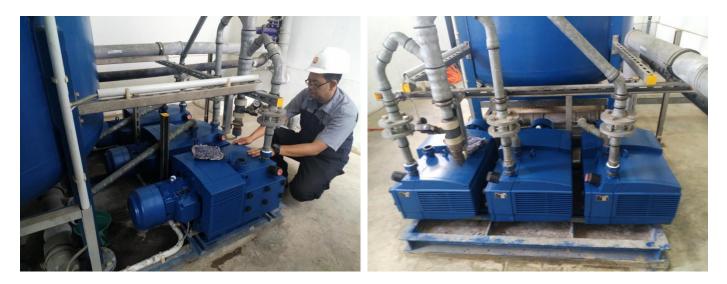
All pumps re-installed and inspected :

- Perfectly working and system back to operational as it should

- Performance test carried out and the vacuum generates extremely fast
