Roediger Rotary Vane Vacuum Pump Overhauling Works

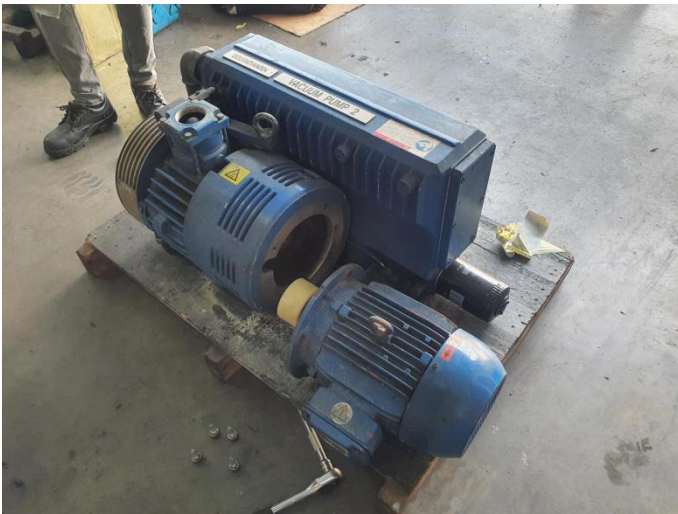
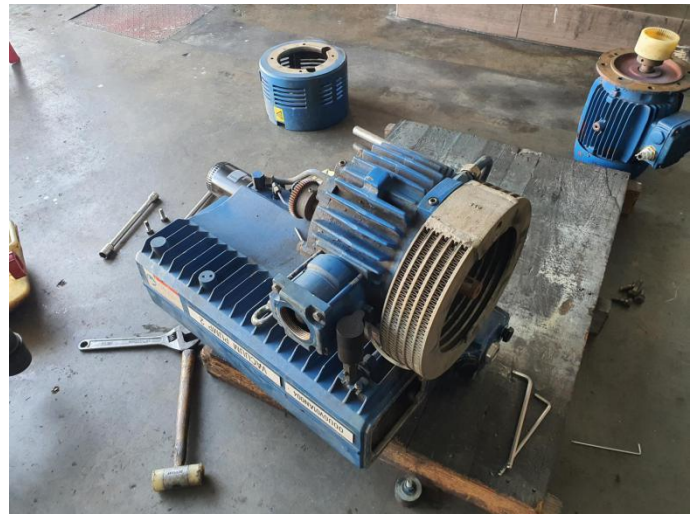
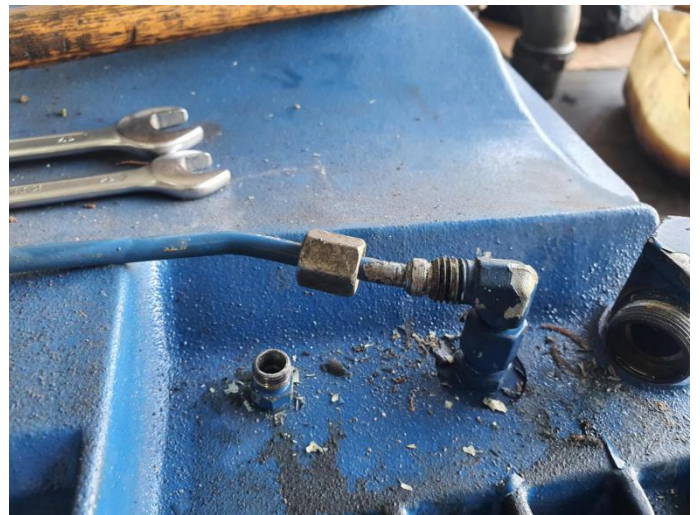
Oil return connection has jammed and damaged - To replace new

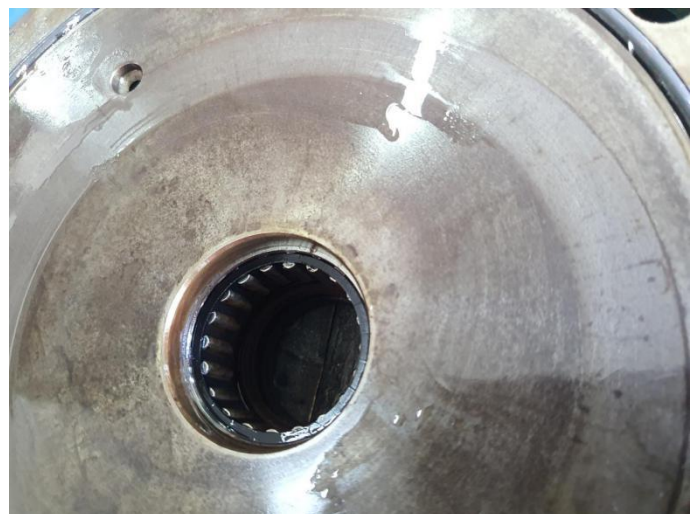
Side plate slightly worn out , Bearing damaged

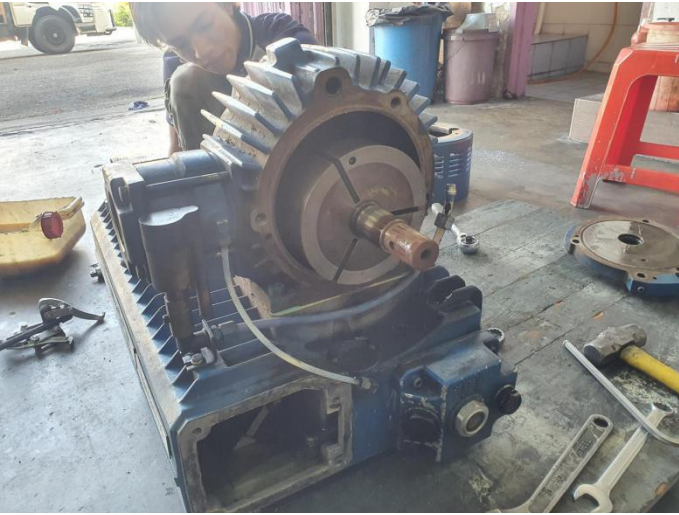
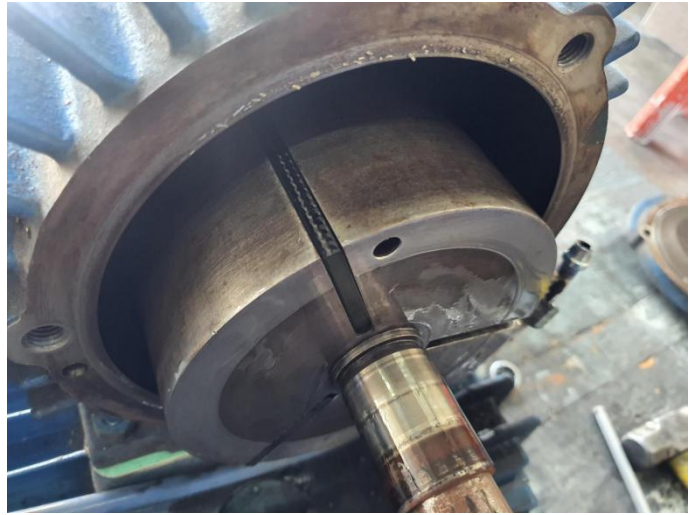
Pump vanes badly damaged , impossible to build pressure

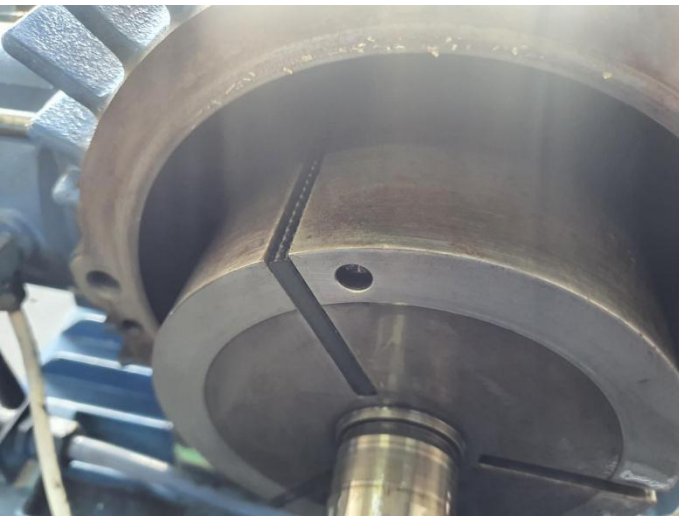
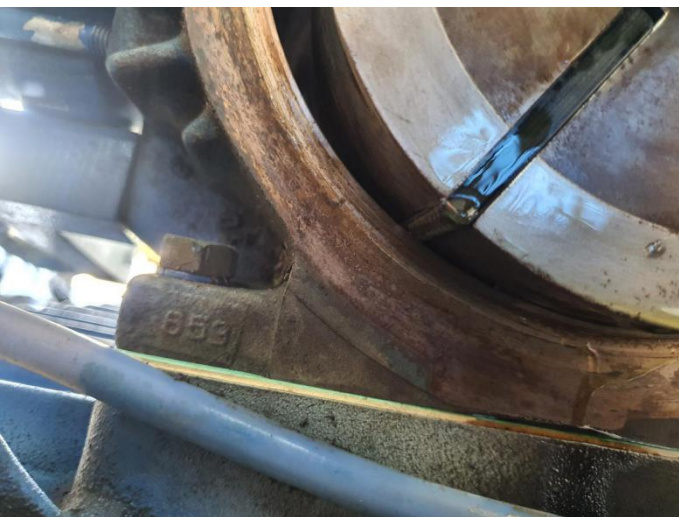
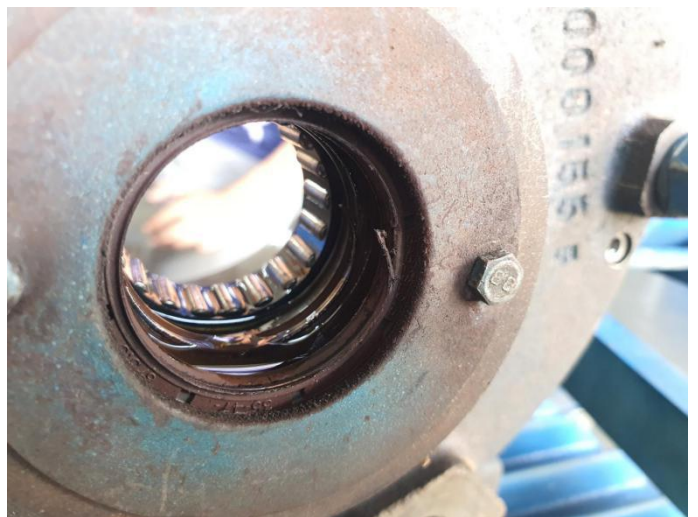
Bearing seal damaged, Vacuum pump oil will always need to top up as it will flow out in exhaust line

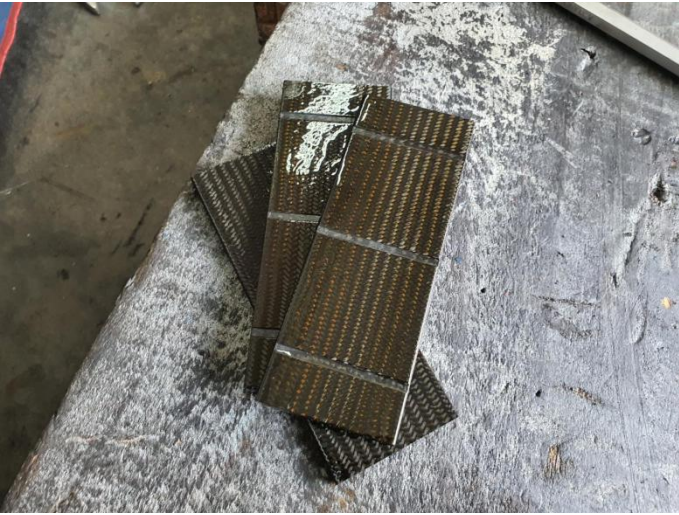
Vanes damaged , rotor requires polishing

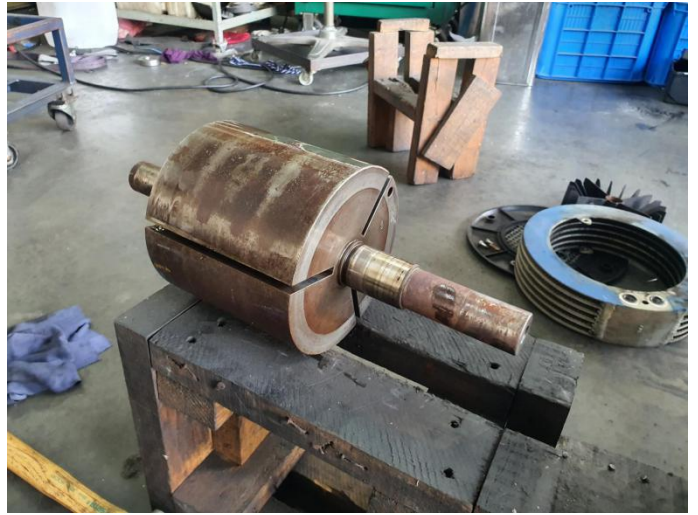
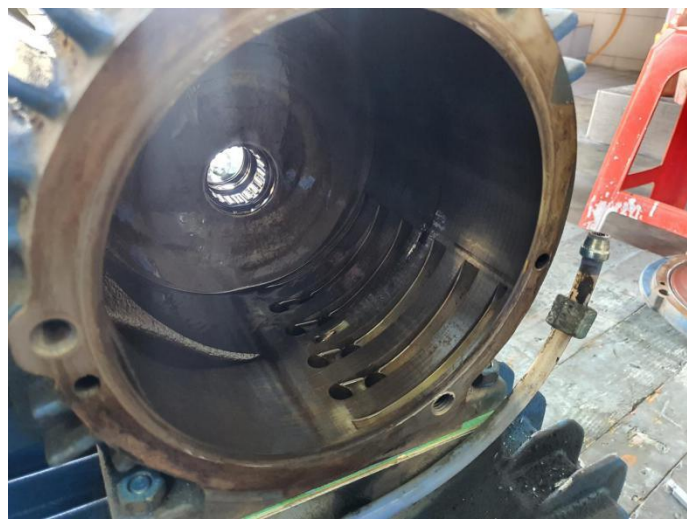
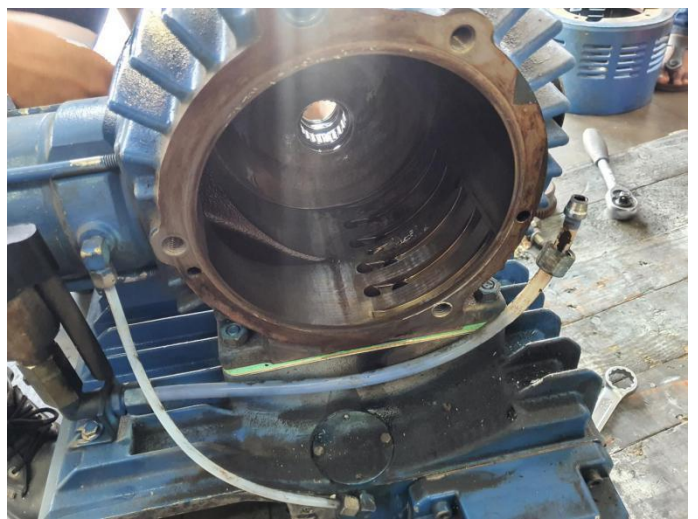
Cylinder worn out , requires polishing to reduce friction upon running

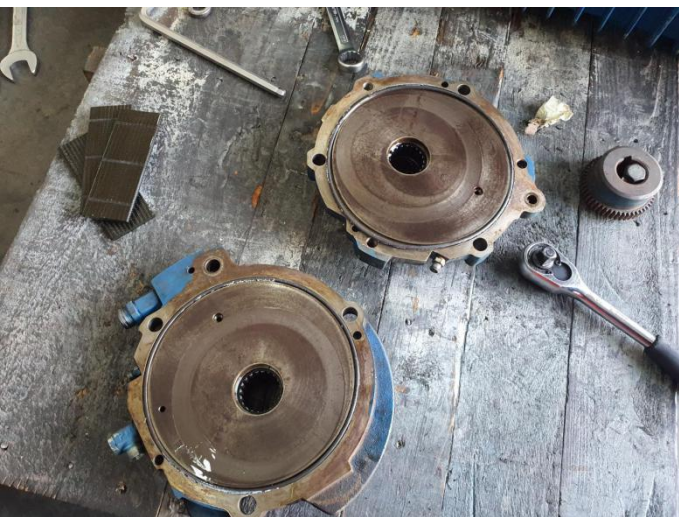
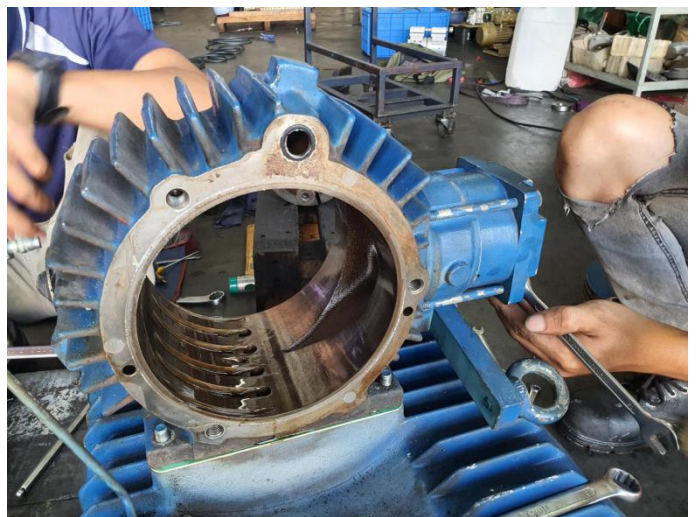
End plate requires polishing

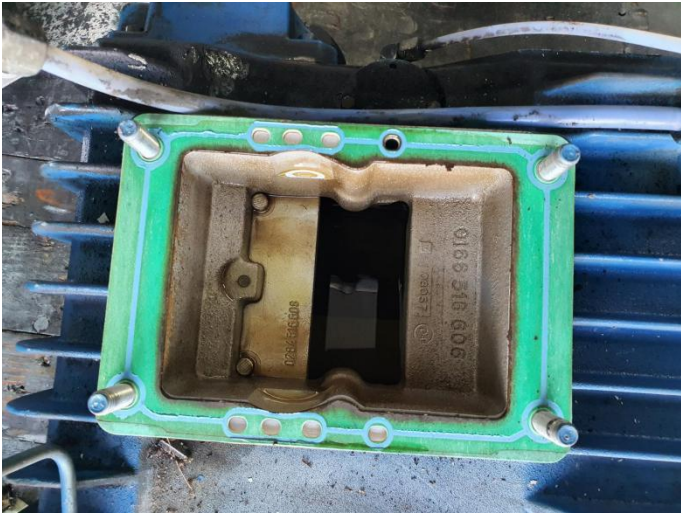
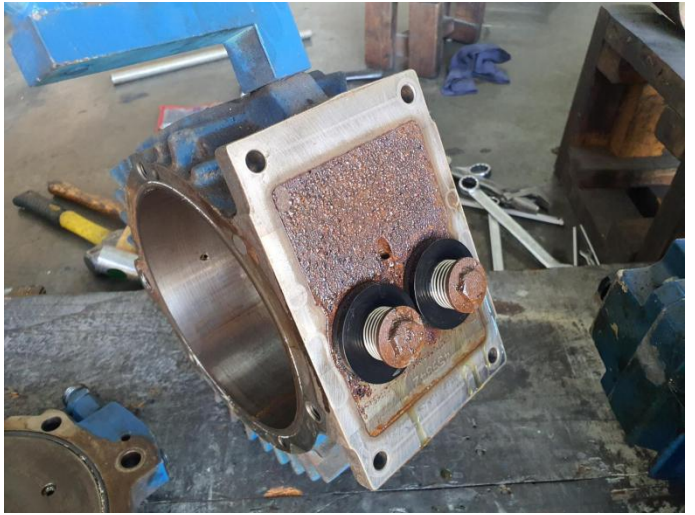
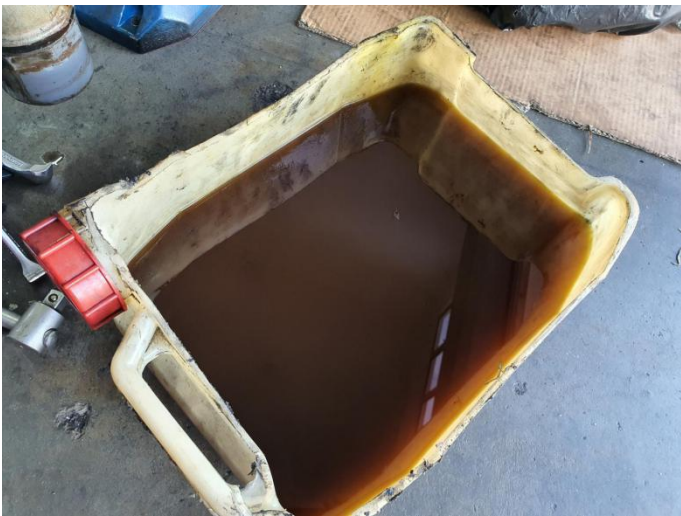
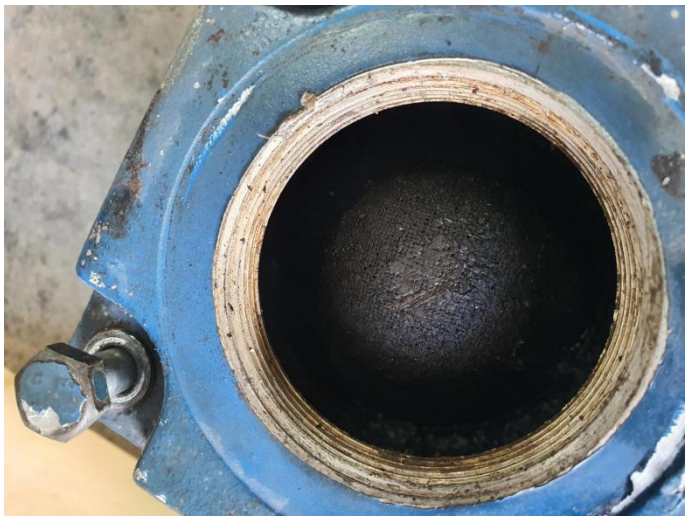
Vacuum pump oil completely emulsified with water and sewage , **not usable**

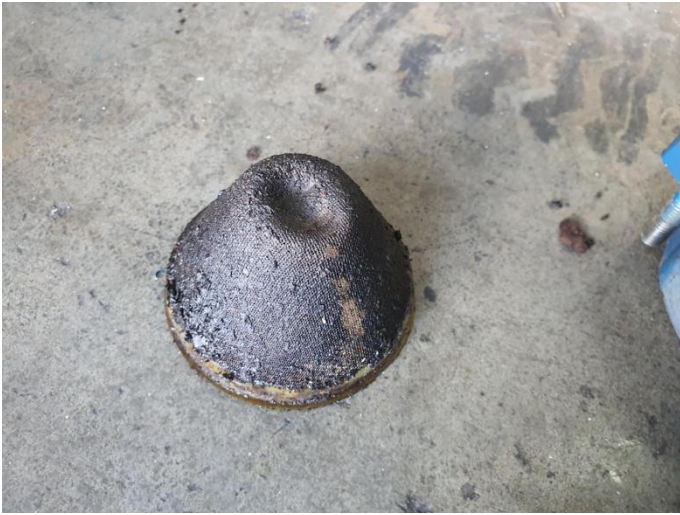
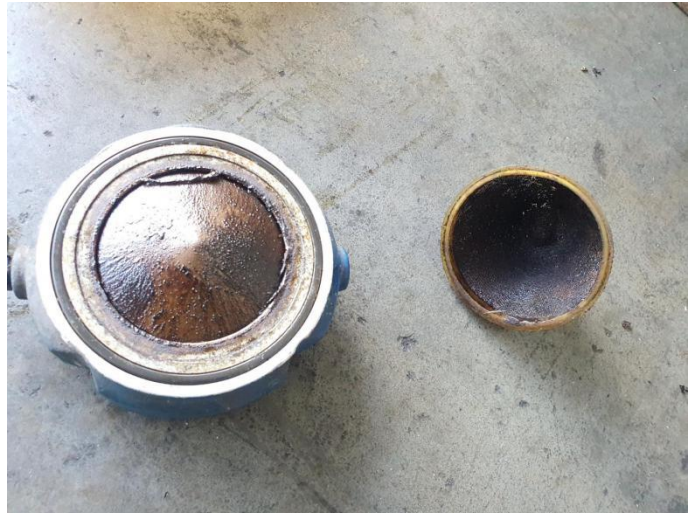
Pump internal strainer choked with dust, debris, sewage and moisture
Installing external strainer is mandatory

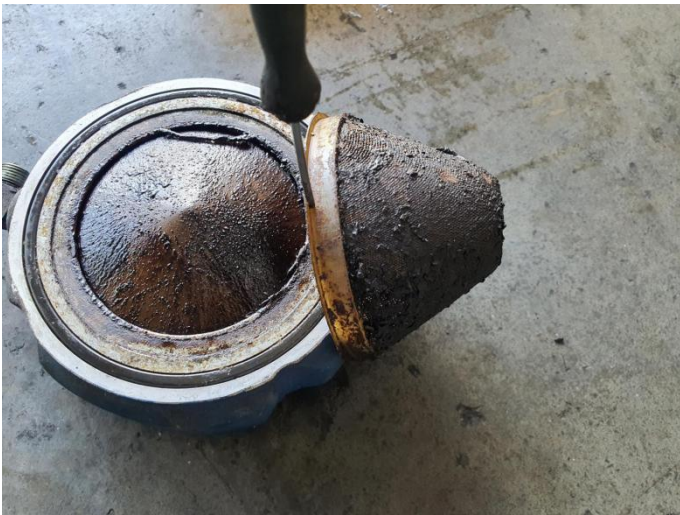
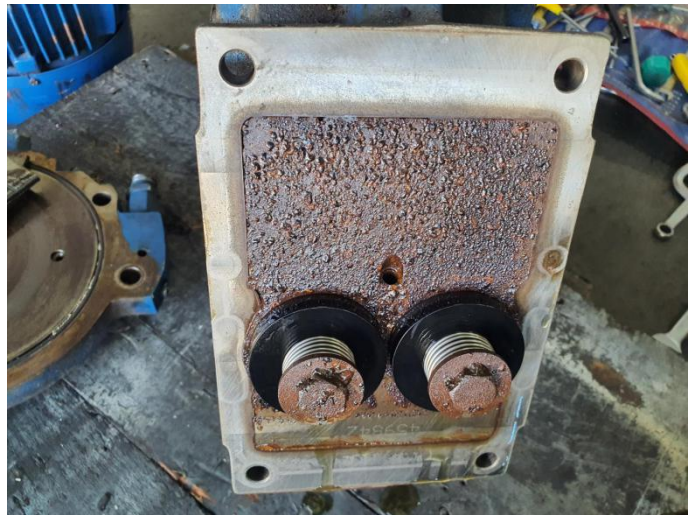
Exhaust valve jammed and the body rusted, damaged due to moisture
Installing external strainer is mandatory
