Compact station vacuum pump exhaust line water ponding troubleshooting works

ASH MANN VACUUM SERVICES SDN BHD

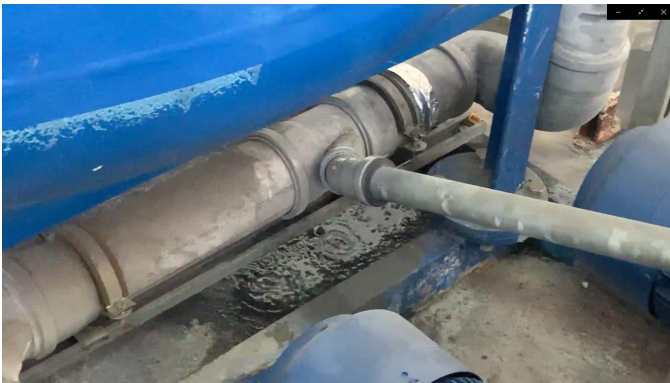
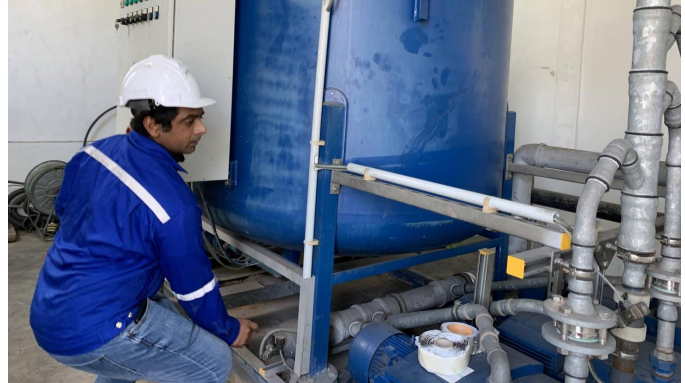
We noticed there was heavy water flow dripping out from the vacuum pump exhaust line.

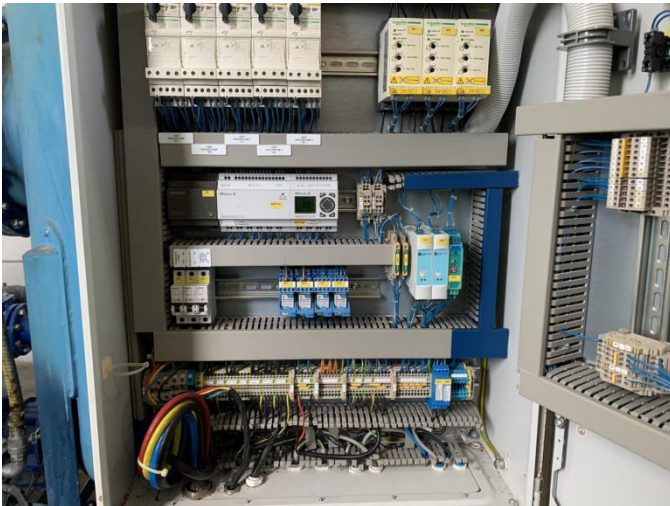
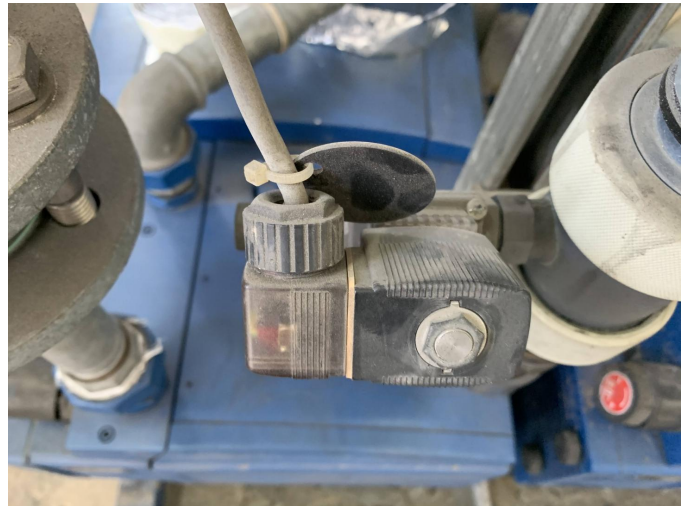
We checked the 24v relay for the condensate trap magnetic valve

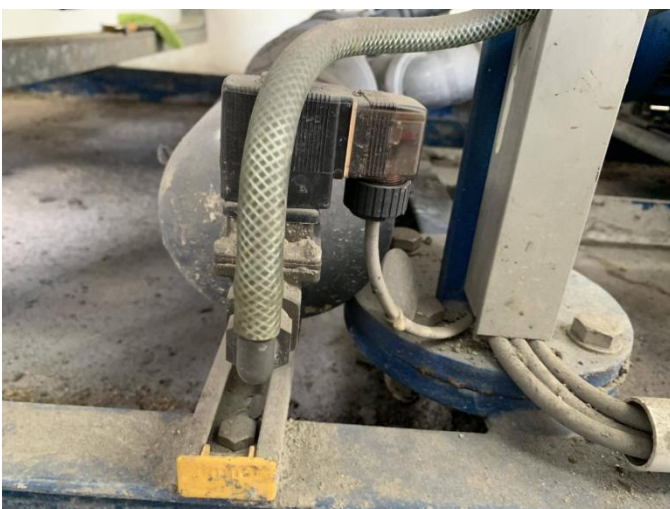
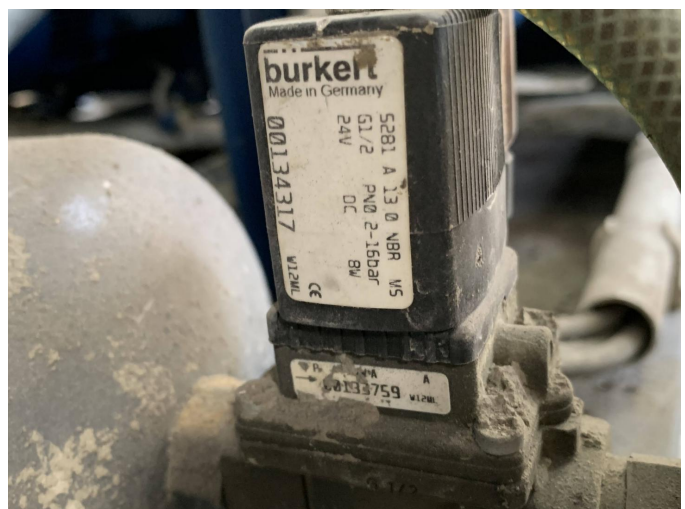
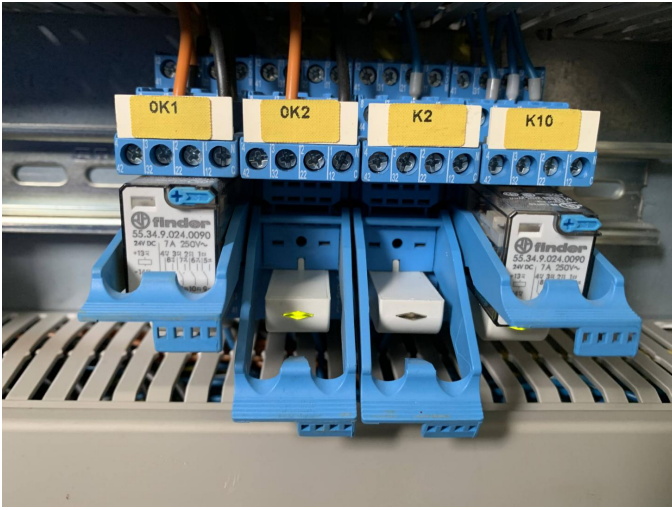
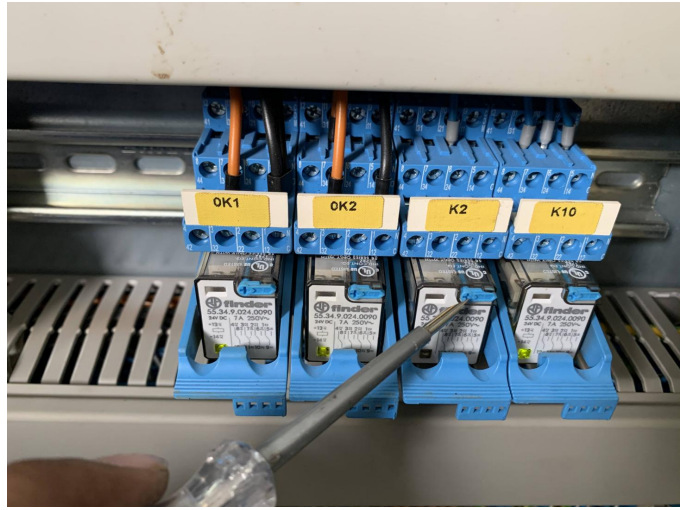
After investigation we conclude there is no problem with the panel

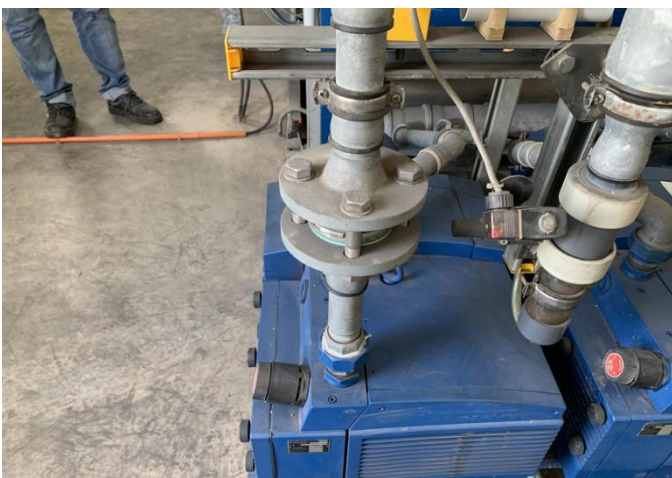
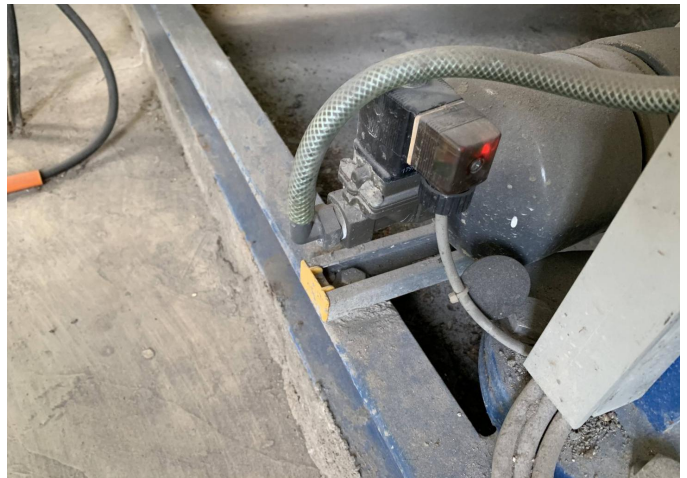
No issues with the condensate trap magnetic valves

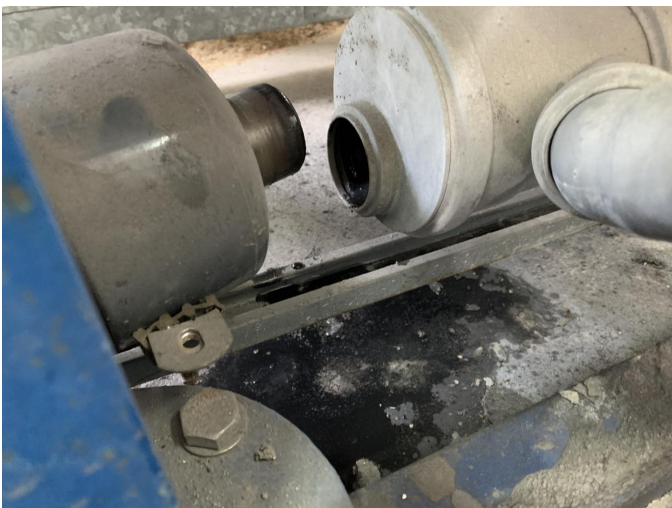
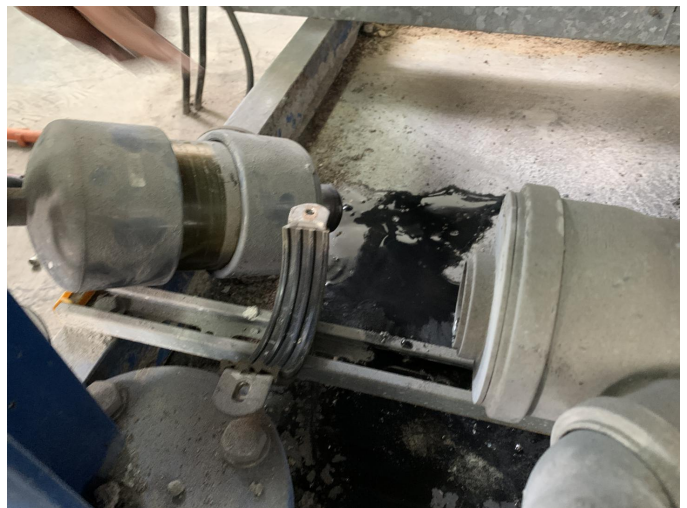
We removed the condensate trap to inspect further

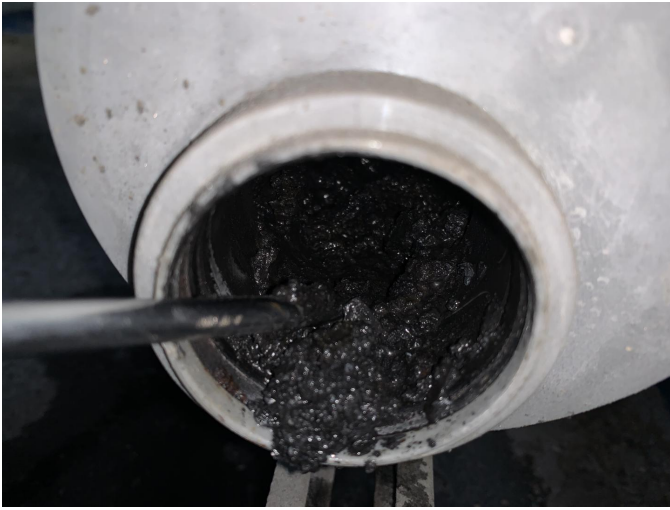
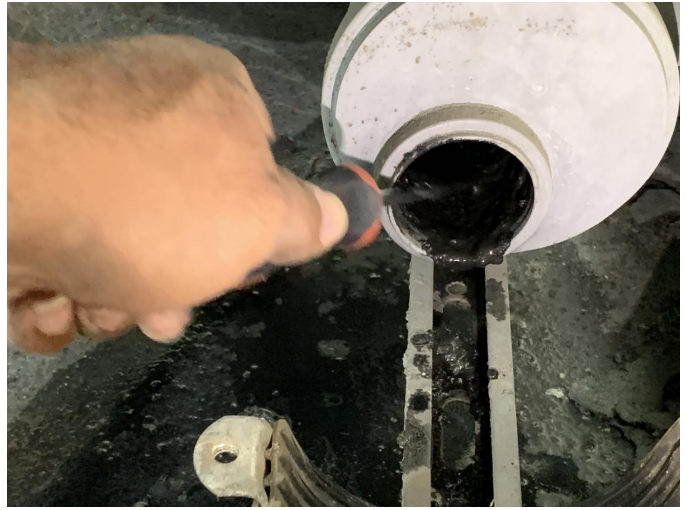
We noticed a piled up debris in the exhaust line

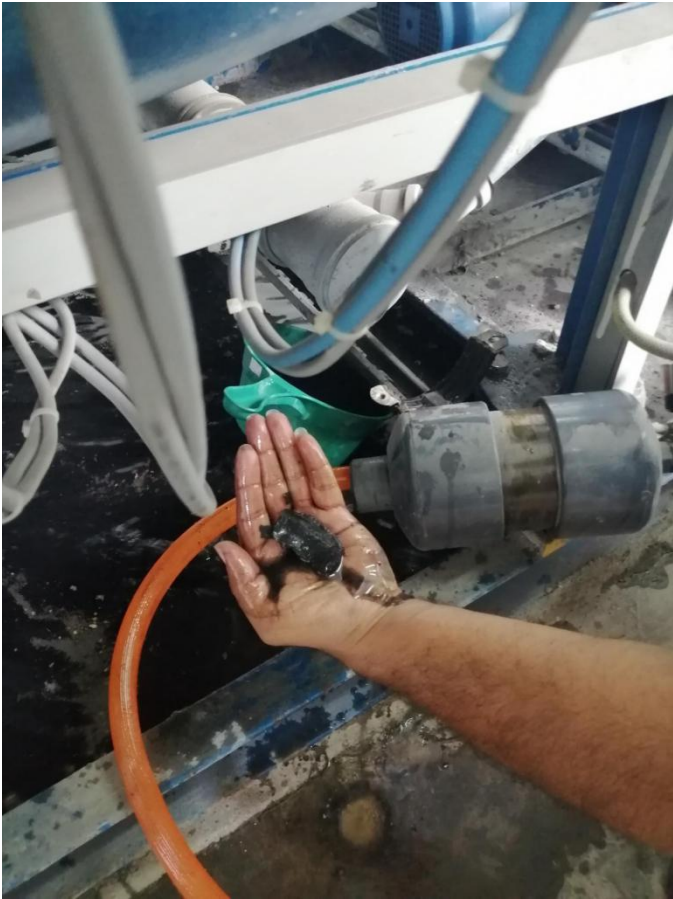
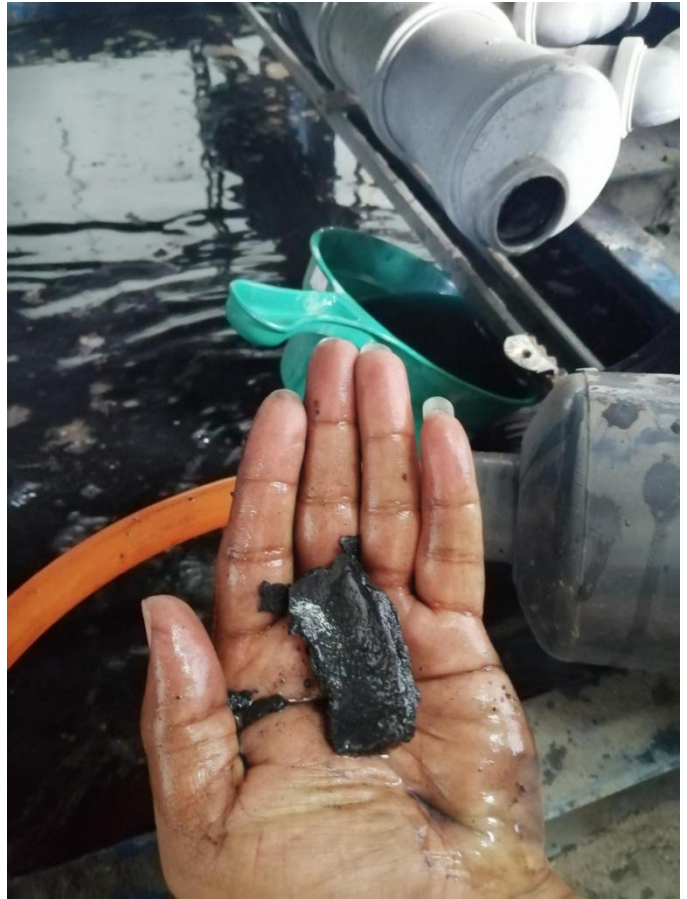
Compacted debris removed from the condensate trap
