Vacuum pump condition inspection :

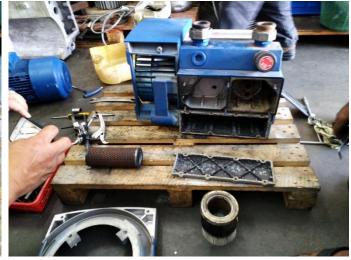
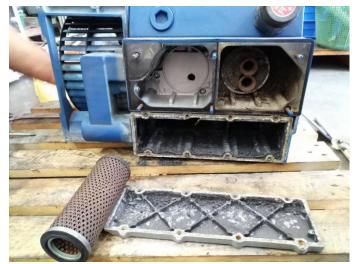
- Vanes found has been warn out
- cylinder has severe scratch marks
- Excessive wear at filtration and exhaust area
- Bearings damaged
